Intel® E8501 Chipset North Bridge (NB)

Specification Update

May 2006

Document Number: 309622-001

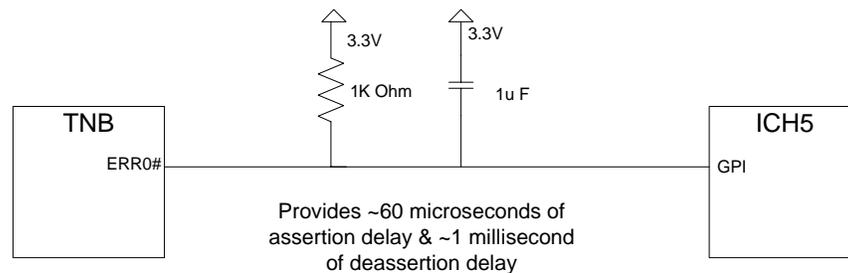
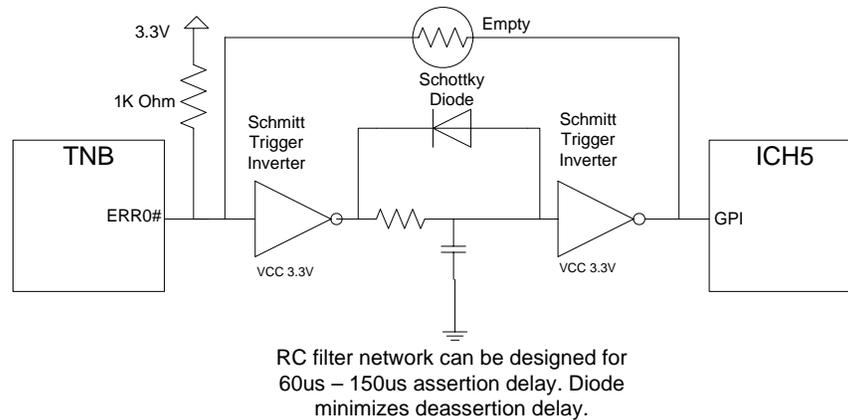
Problem: Any condition routed to MCH ERR[2:0]# output pins for SMI# escalation that would result in data poisoning on FSB will result in a CPU IERR# assertion due to race condition. The race condition exists between poisoned data presented to the FSB by the MCH and the uncorrectable error escalated to SMI# via ERR[2:0]# pins. If the CPU observes an SMI# assertion before the poisoned data is presented to the FSB, the CPU asserts MCERR# followed by IERR#. The CPU expects the SMI# assertion to occur at least 10 BCLKs after the associated MCERR# assertion. Conditions that result in data poisoning on FSB are uncorrectable memory ECC errors or poisoned TLPs received from any PCI Express* port.

Implication: CPU may assert IERR# and cause a system hang before the error may be logged in SMM.

1. Log errors upon reboot
 - System components (TNB, CPU, Southbridge) preserve errors across warm resets via sticky error registers
 - Requires a mechanism to reset system upon IERR# (server management controller, depress system reset button, etc.)
2. Delay SMI# assertion by inserting a 60µs-150µs delay on the ERR0# pin
 - Two recommended circuit solutions (other solutions may be possible):

- Route errors that result in FSB data poisoning to the ERR0# pin (IO4, M2, M4-13, M15)

3. Disable FSB data parity (ECC on Potomac/Tulsa) checking on CPU
 - Prevents CPU from asserting MCERR# on poisoned data
